STRUCTURAL CONDITION SURVEY OF EXISTING MIDDLETOWN MUNICIPAL PARKING GARAGE

MIDDLETOWN COURTHOUSE PROJECT
MIDDLETOWN, CONNECTICUT

APRIL 1992

PURCELL
ASSOCIATES

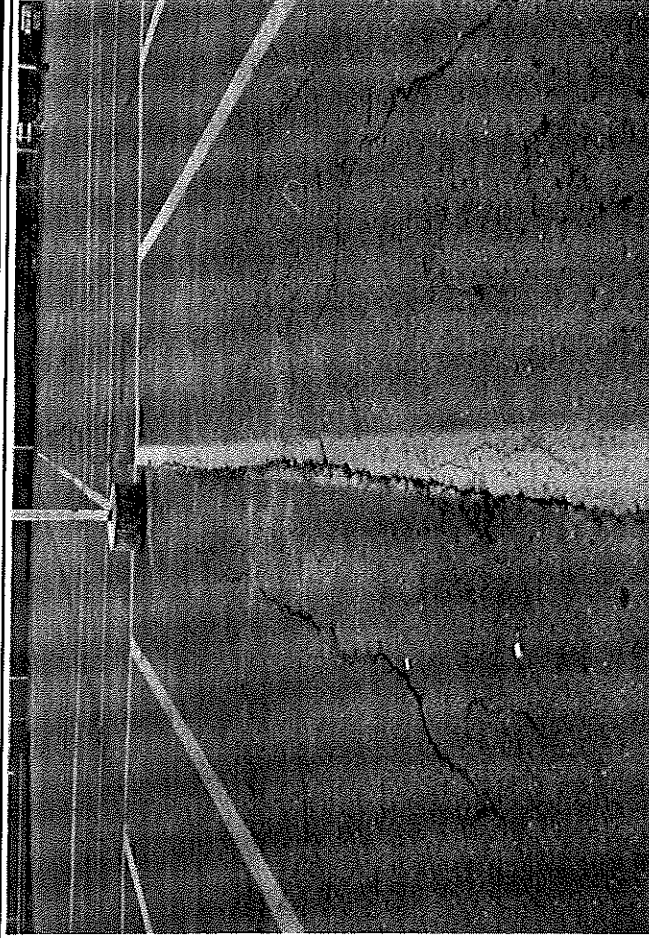
38

37. Map cracking in bituminous concrete wearing surface.
38. Random cracks in bituminous concrete wearing surface.
39. Ponding in bituminous concrete wearing surface.

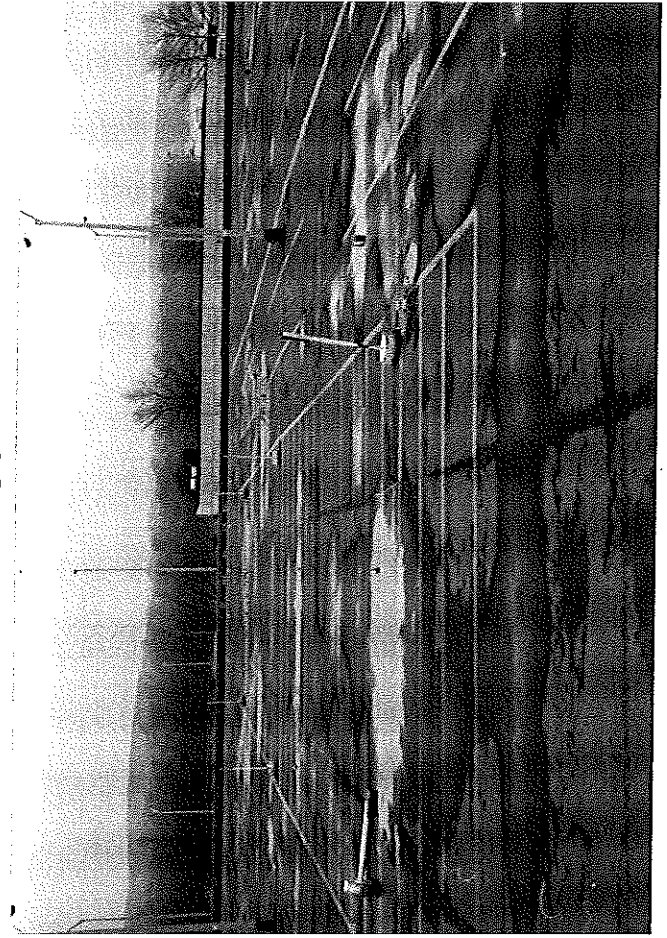
40

40. Ponding in bituminous concrete wearing surface.
41. Leakage stains and efflorescence on the underside of tee flange, along expansion joint between lines '21' and '22'.

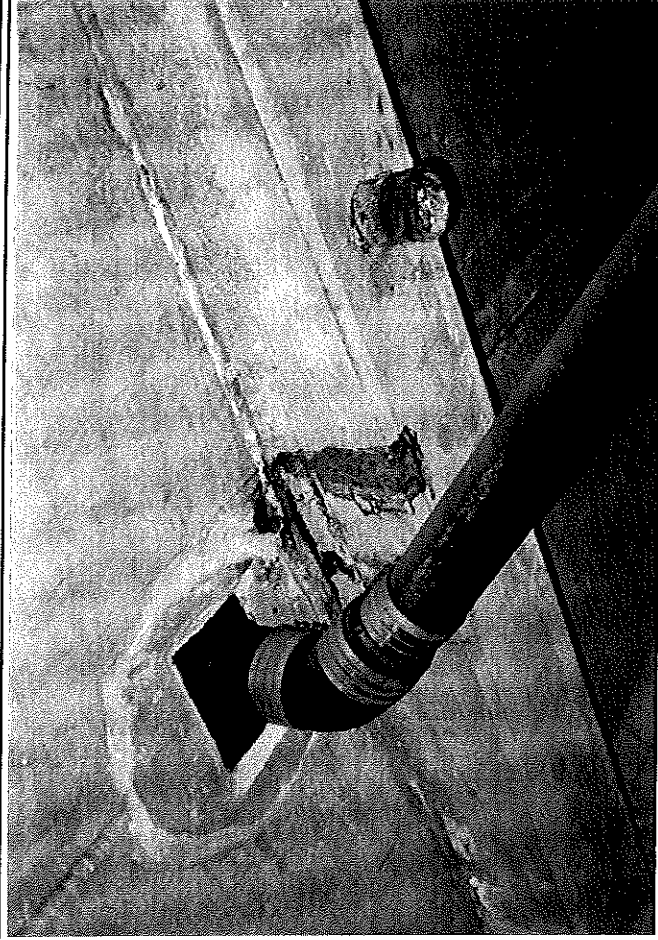
42

42. Lightly rusted embedded plate and top elbow of the drain pipe.
43. Cracked curb with rust stains at rail post base.
44. Large spall in concrete curb with rusted rail post base near the top of pedestrian ramp.

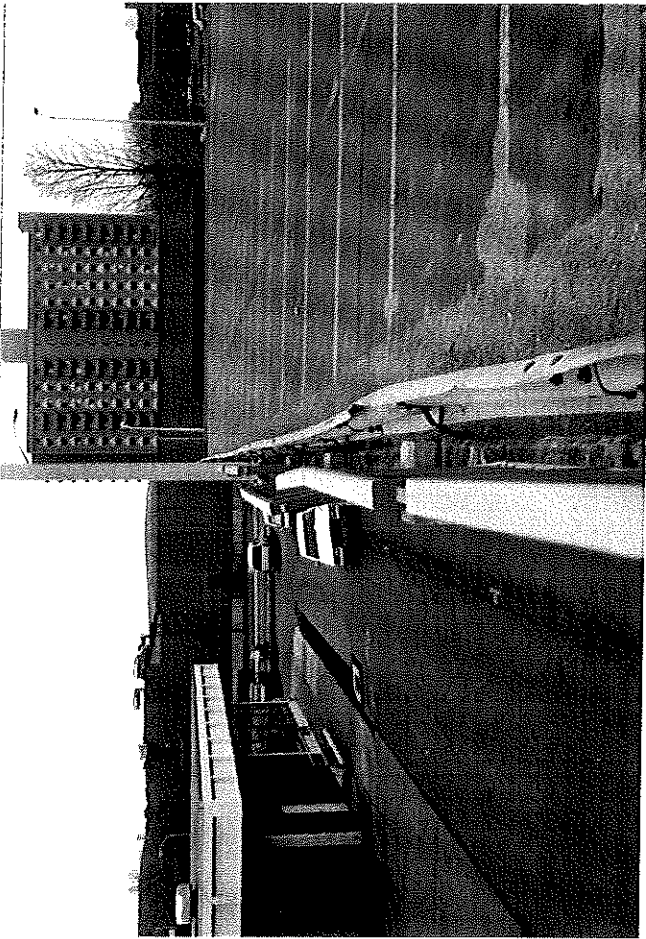
45

45. Damaged pedestrian railing and guard railing between 'E/20' and 'E/22'.
46. Guard rail anchorage plate pulled off the curb near column 'E/21'.
47. Numerous cracks in concrete topping at Stair No. 1.

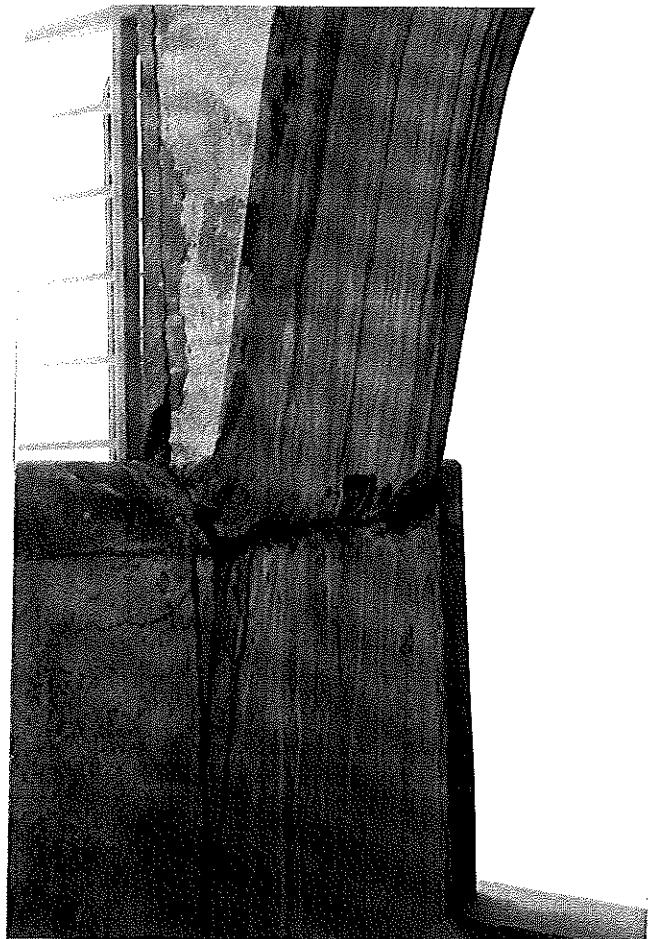
48

48. Large spalls with exposed rusted rebars on the underside of Stair No. 1 connection to upper deck.
49. Wide longitudinal crack with rust stains near top of column 'A/26'.

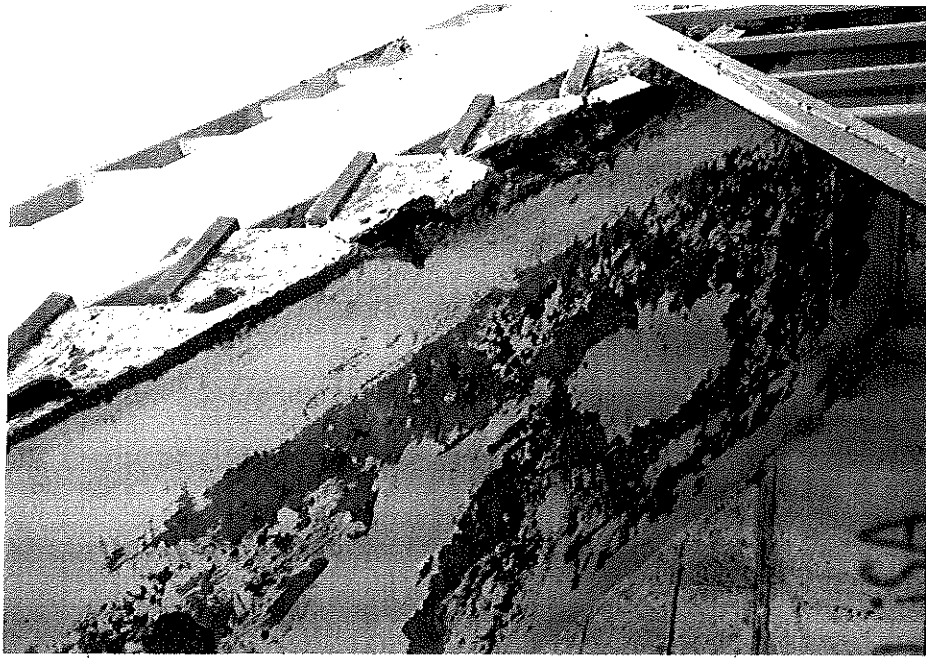
50

50. Sealing on the underside and spalling along the edge of cast-in-place stairs at upper level at Stair No. 2.
51. Severely cracked concrete encasement with several spalls at the southwest corner of the pedestrian bridge (at the northeast corner of Sears Building).

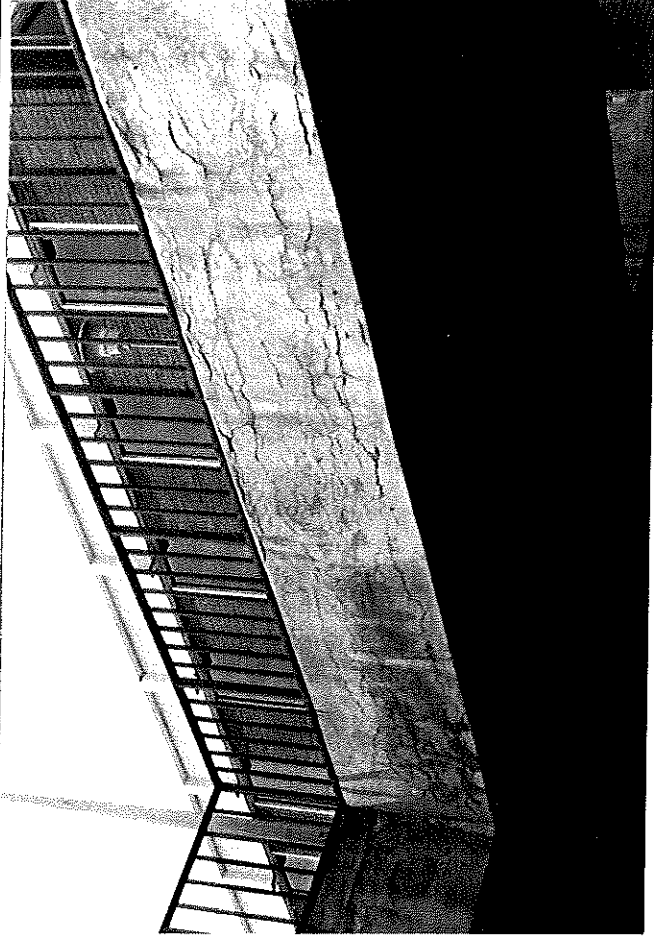
52

52. Numerous cracks on the exterior face of concrete encasement around the W27 girder.
53. A large crack in masonry at Stair No. 2.
54. Numerous cracks with efflorescence and stalactites in the concrete encasement around the W27 girder.

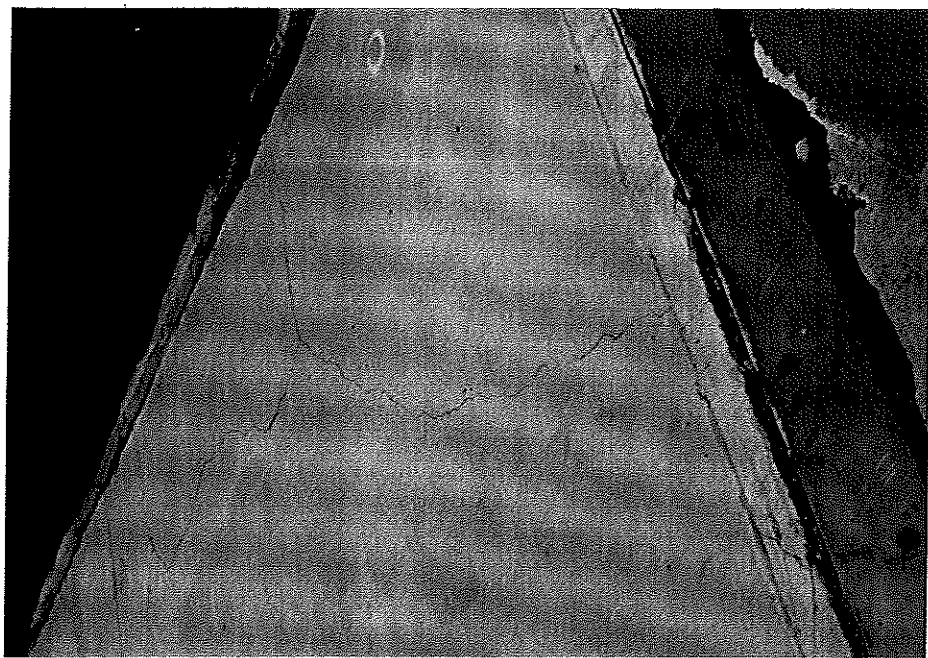
63

57. Underside of pedestrian bridge looking west. Stalactites and efflorescence can be seen in concrete encasements around W27 girders.
58. Underside of pedestrian bridge looking east and west elevation of Stair No. 2. Severely deteriorated masonry infill underneath pedestrian bridge can be seen.
59. Steel pipe column heavily rusted near top and severely deteriorated masonry infill.
60. Cracked masonry infill and steel column that is heavily rusted near top.
61. Heavily rusted and delaminated steel beam at the northeast corner of Sears Building.
62. Heavily rusted and delaminated south end of transverse girder that supports the W27 girders and pedestrian bridge.
63. Random cracks in concrete topping over pedestrian bridge deck slab.
